December 1981

**THE STREAMBANK EROSION CONTROL
EVALUATION AND DEMONSTRATION ACT OF 1974
SECTION 32, PUBLIC LAW 93-251**

Appendix B - Hydraulic Research

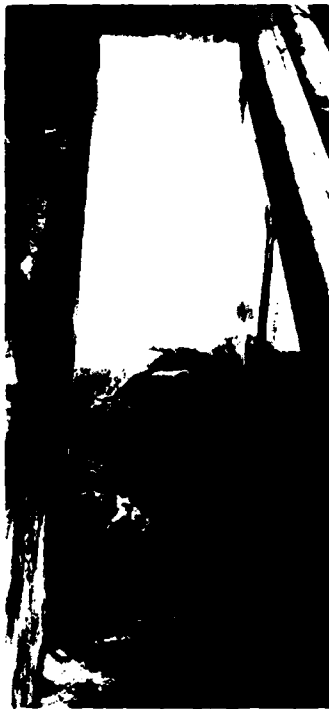
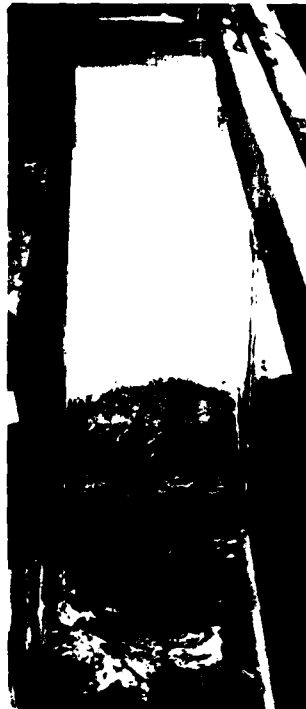
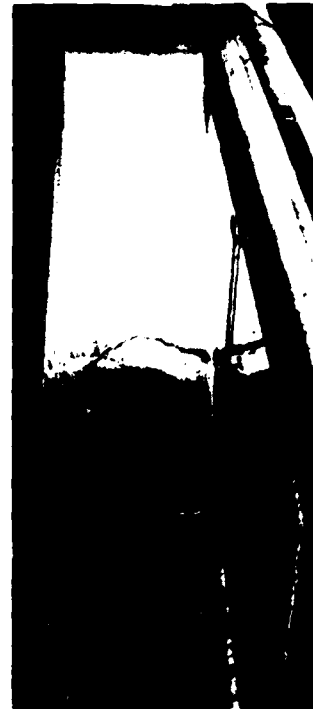
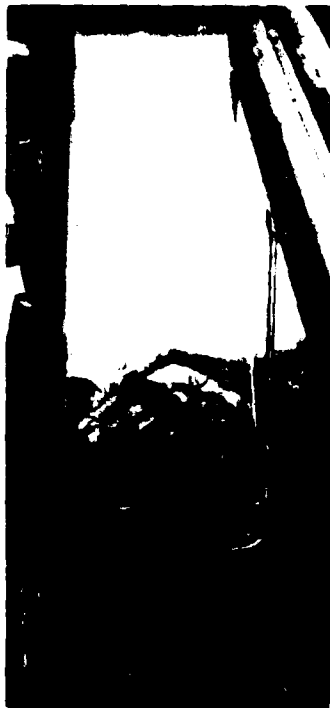
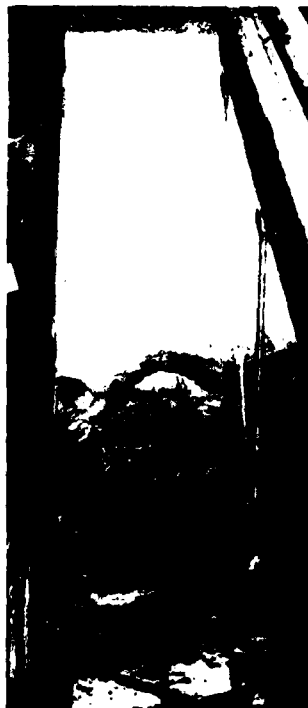
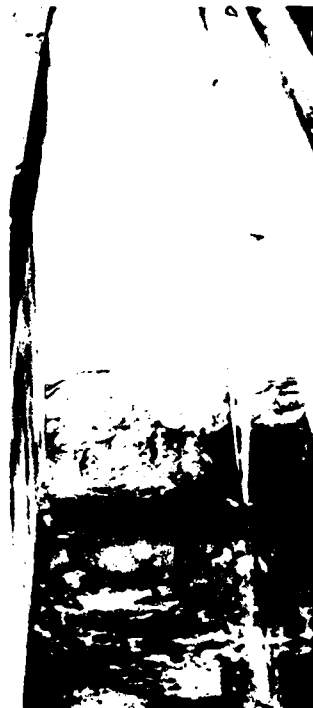
d. 11 days

e. 14 days

30. Plan 1 was rebuilt and Figure 45 shows the streambank at the start of the 1.0-ft-static differential head test. The damage to the slope became progressively worse as the test proceeded and had not stabilized when the test was stopped after 461 hr (about 19 days). Figure 46 shows conditions at the end of the test; Figure 47 shows the condition of the streambank slope at intervals throughout the test.

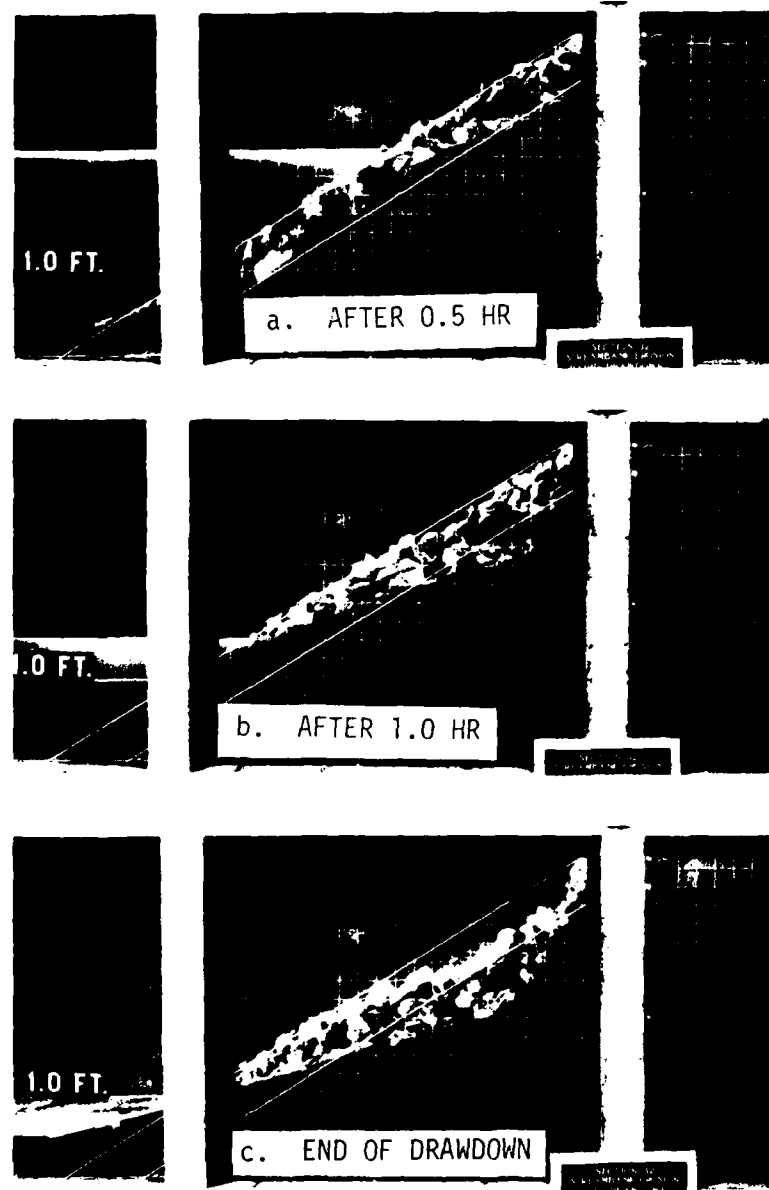
Figure 62. Plan 4, at various times during the 2.0-ft/hr drawdown test

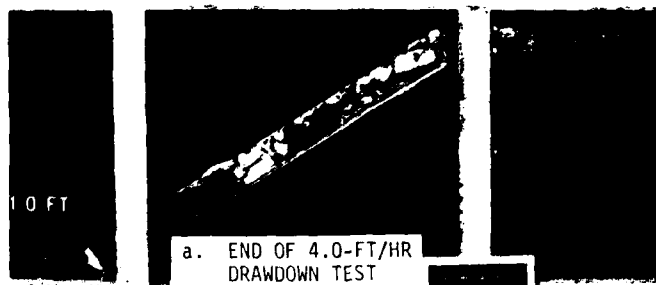
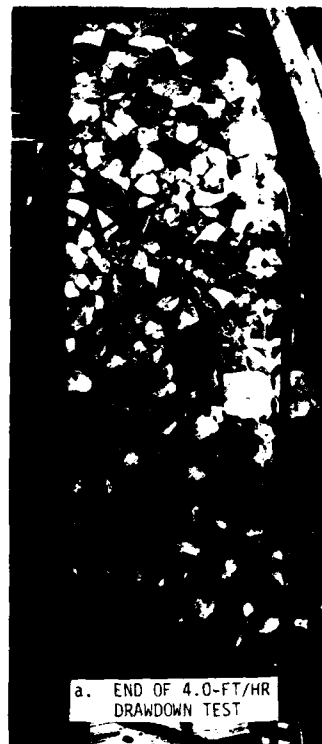
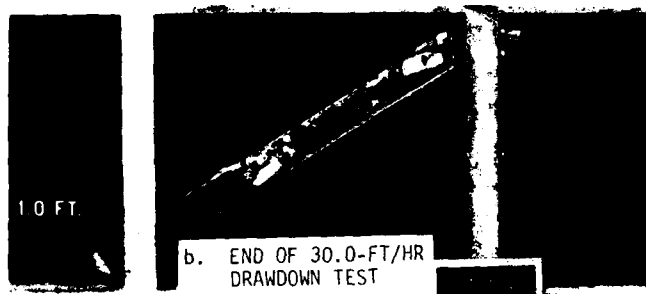
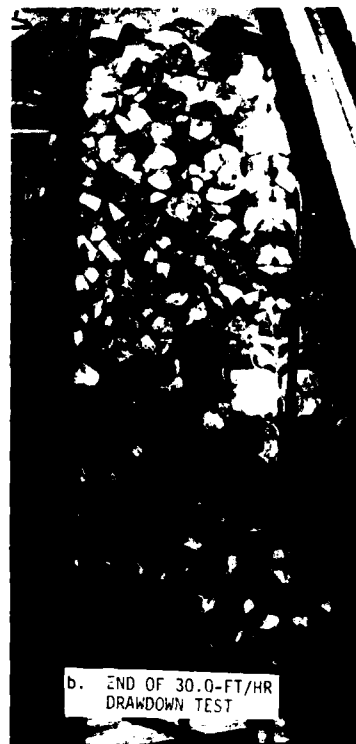
Figure 67. Plan 6, at end of the 4.0-ft/hr drawdown test and
at end of the 30.0-ft/hr drawdown test

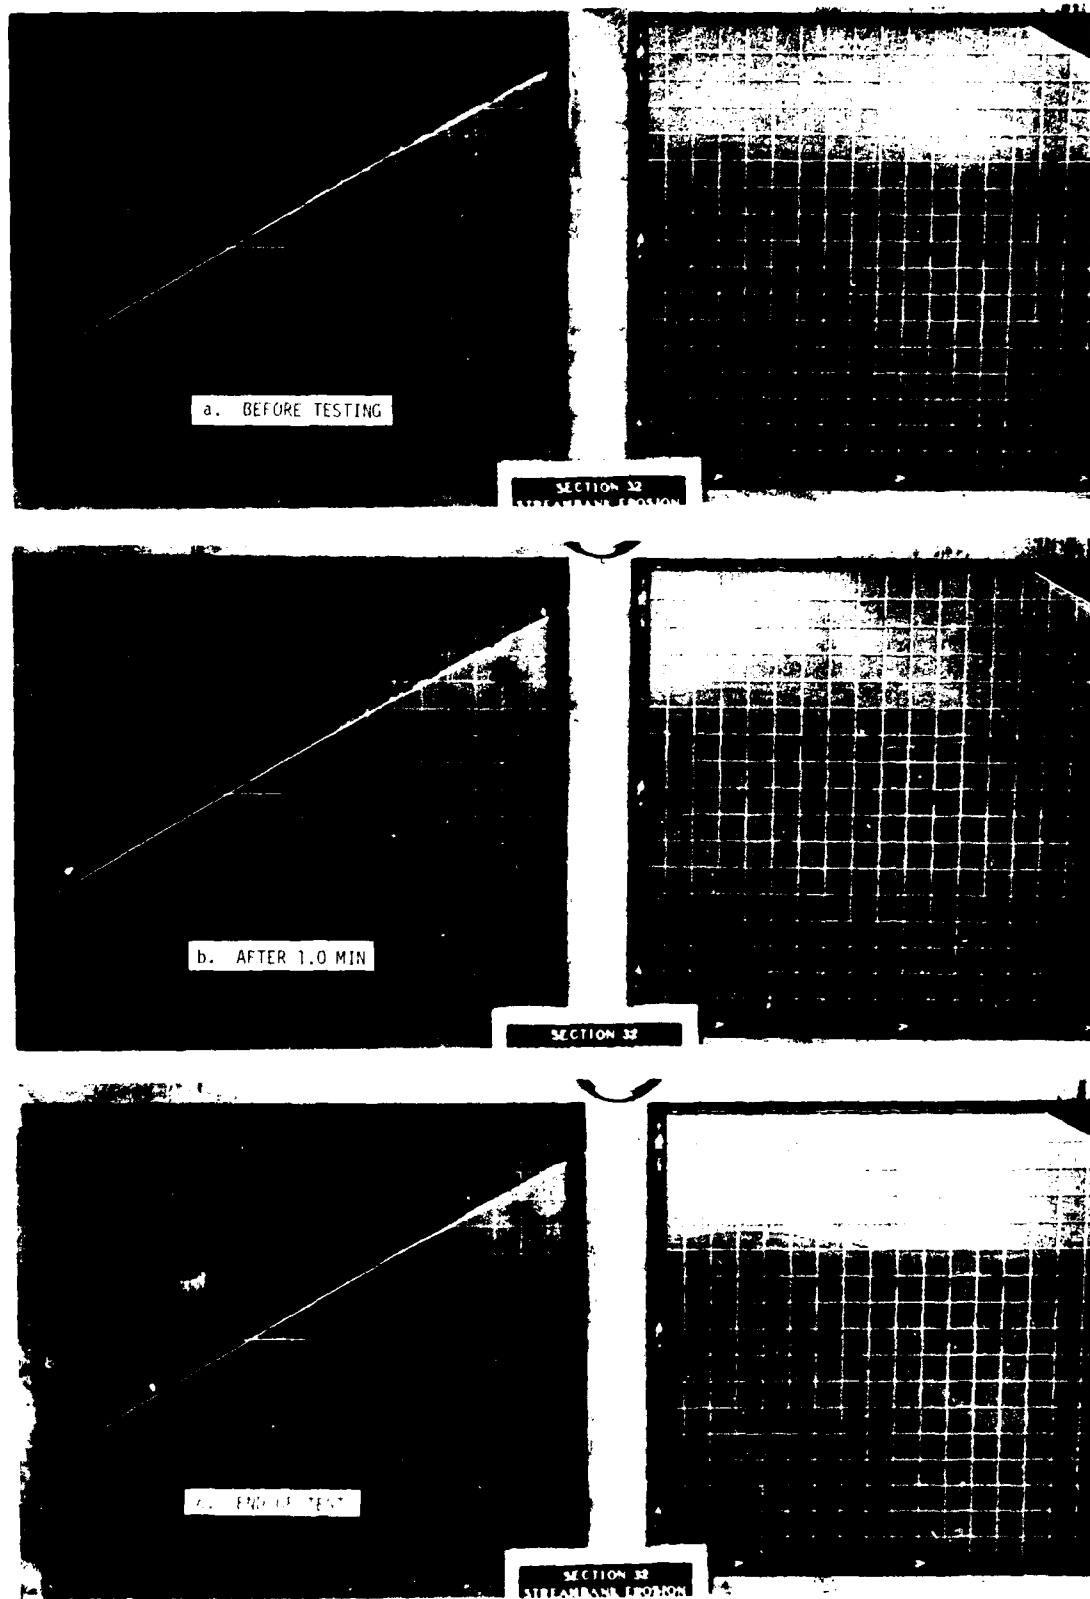
Figure 71. Plan 7, before testing, at 1.0 min, and at end of Test 4

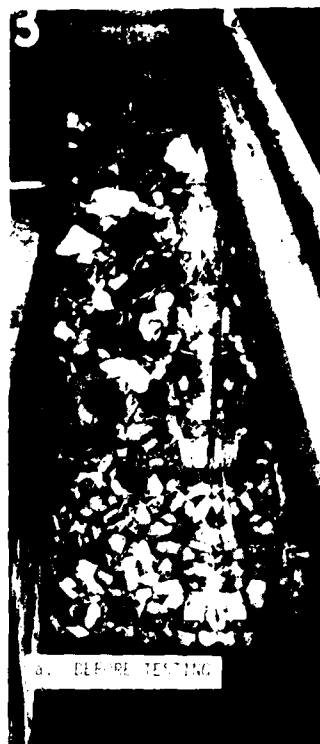
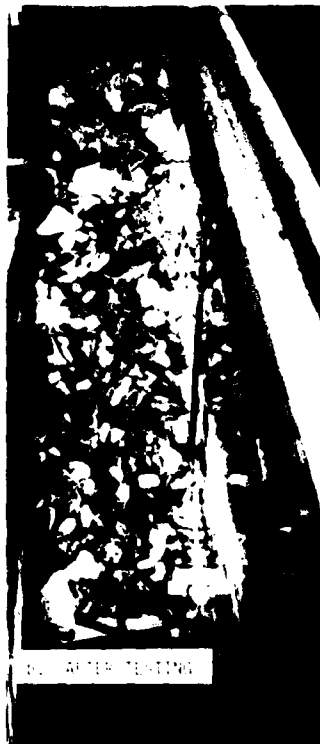
Figure 72. Plan 3, before and after testing 2.0-sec,
0.70-ft nonbreaking waves

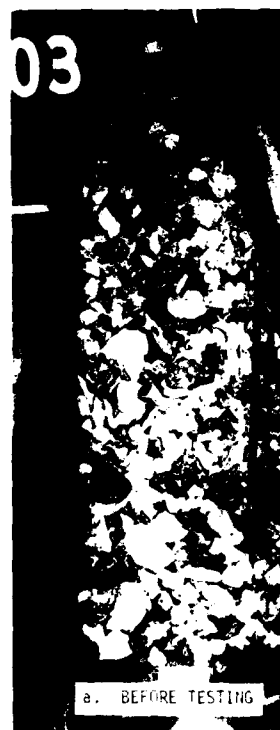
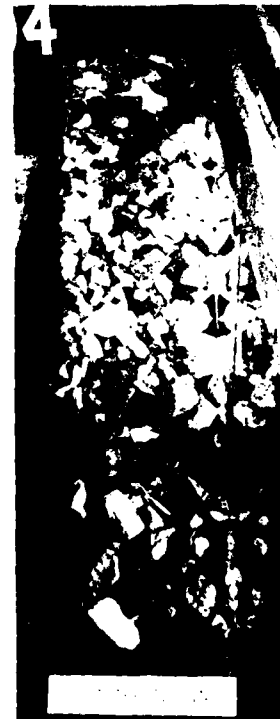
Figure 74. Plan 5A, before and after testing 2.0-sec,
0.70-ft nonbreaking waves

1. Plan 3, Figures 72 and 73
2. Plan 5A, Figures 74 and 75
3. Plan 6, Figures 76 and 77

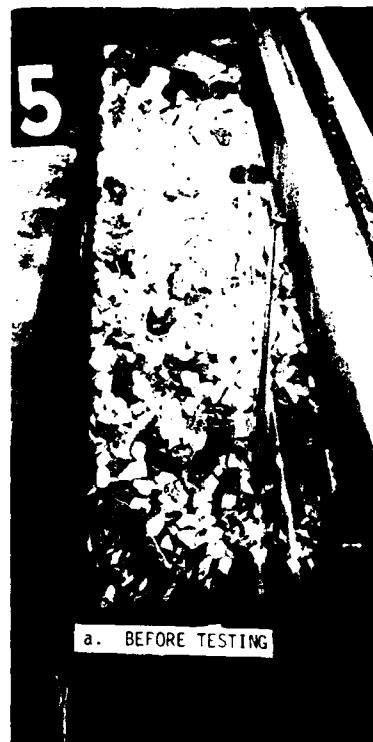
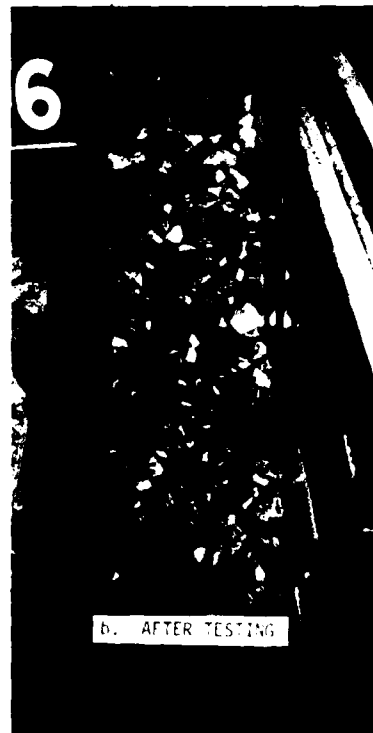
Figure 77. Plan 6, before and after testing 4.0-sec,
0.70-ft nonbreaking waves

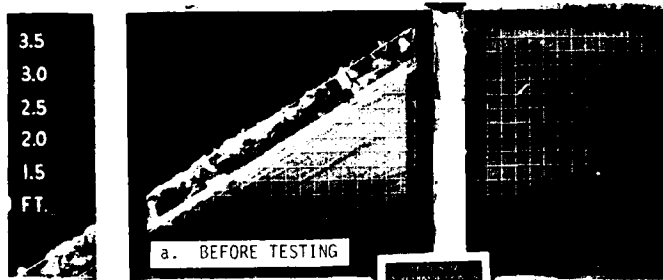
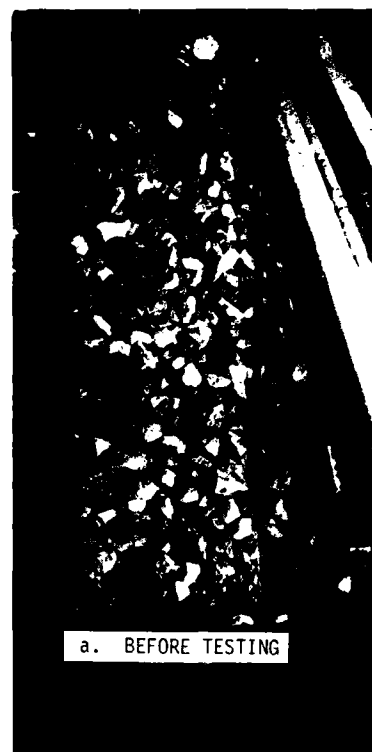
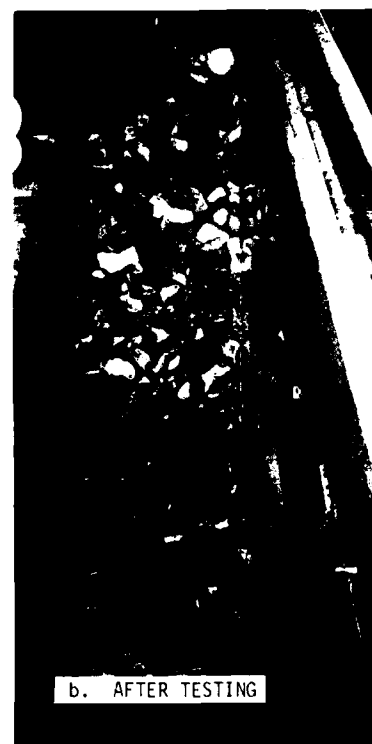
Figure 81. Plan 6, before and after testing 2.0-sec,
0.75-ft nonbreaking waves

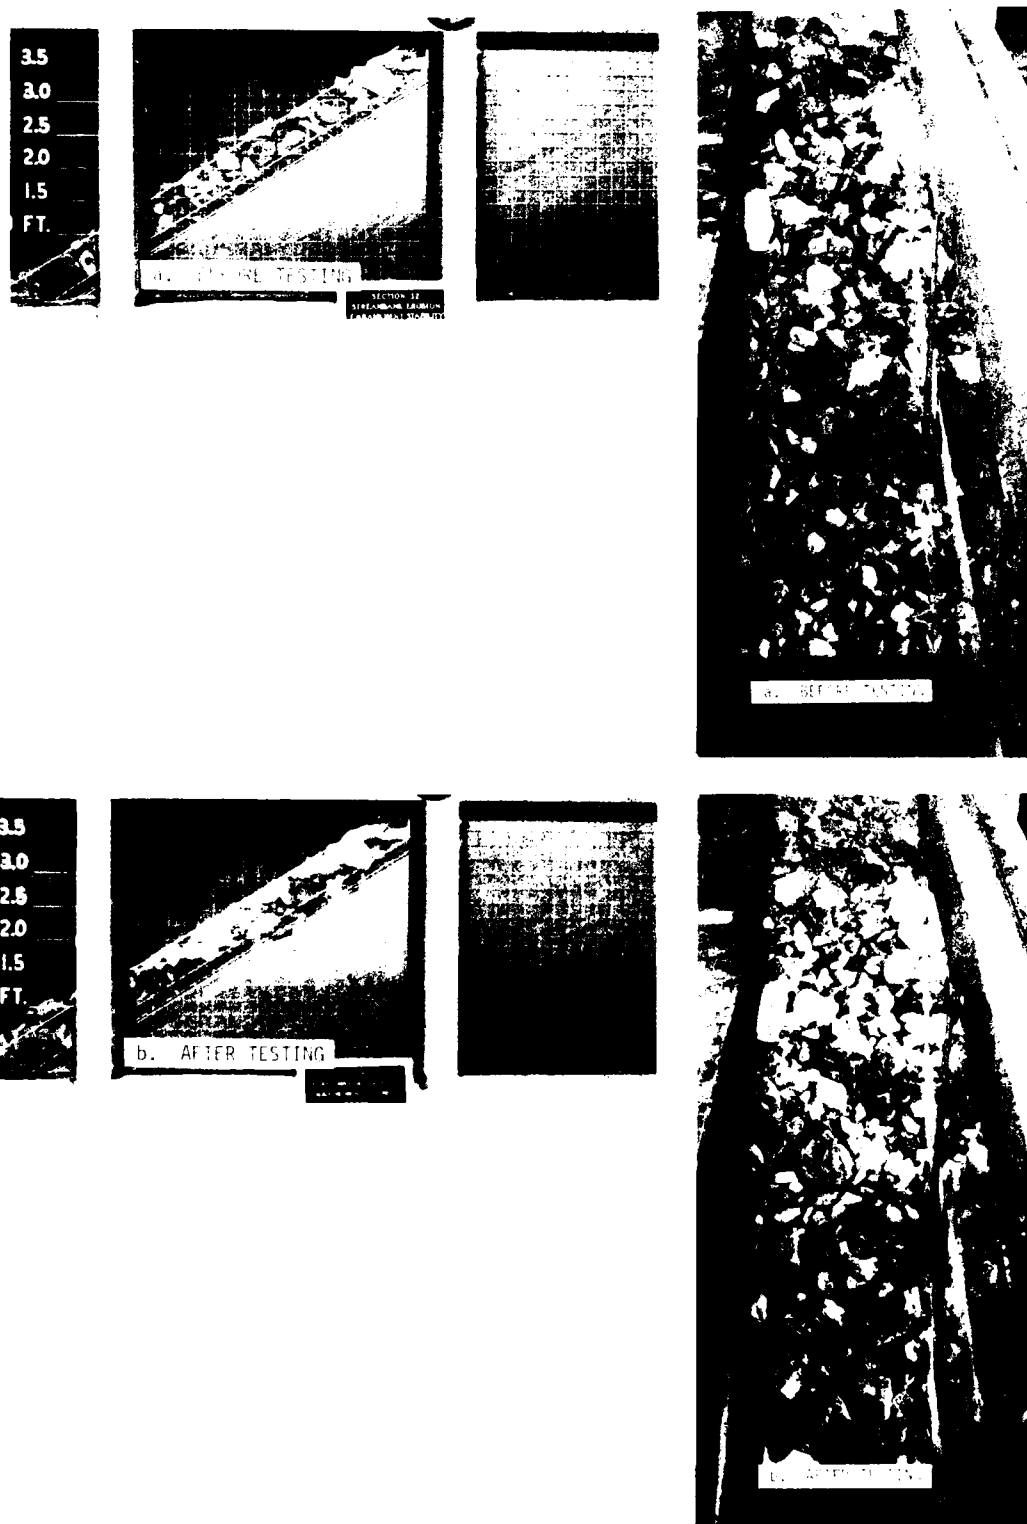
Figure 82. Plan 3, before and after testing 2.0-sec, 0.70-ft non-breaking wave combined with 1.5-ft static differential head

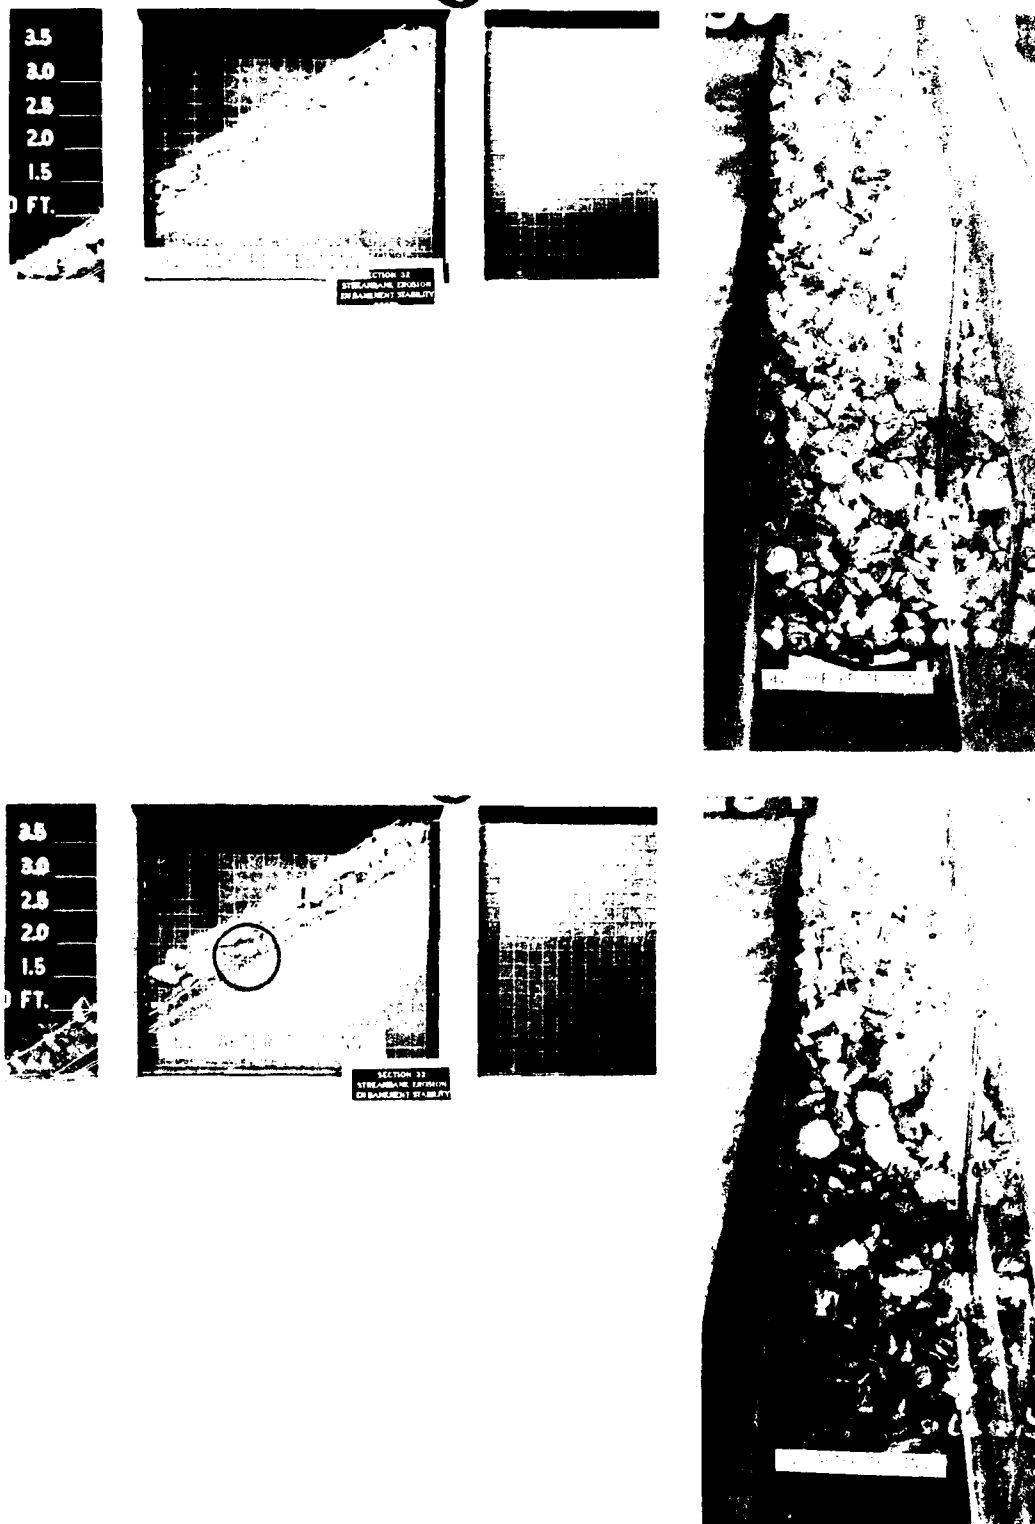
Figure 88. Plan 3, before and after testing 2.0-sec, 0.75-ft non-breaking wave combined with 1.5-ft static differential head

49. Plan 3 (Figure 88a) was tested with 2.0-sec, 0.75-ft nonbreaking waves and the 1.5-ft static differential head to see if the increased wave height would cause a larger amount of disruption and leaching of granular filters than what had occurred with the 0.70-ft waves. The riprap sustained moderate damage and the granular filter was exposed and started to leach through the riprap. This did not result in any significant damage to the sand streambank. All damage had subsided at the end of the test and the granular filter that leached through the riprap can hardly be detected in the after-test photographs (Figures 88b).

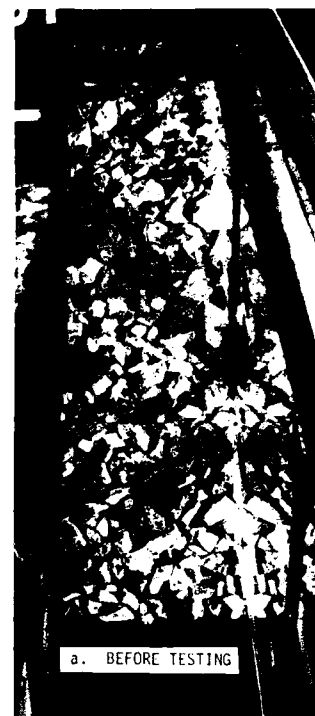
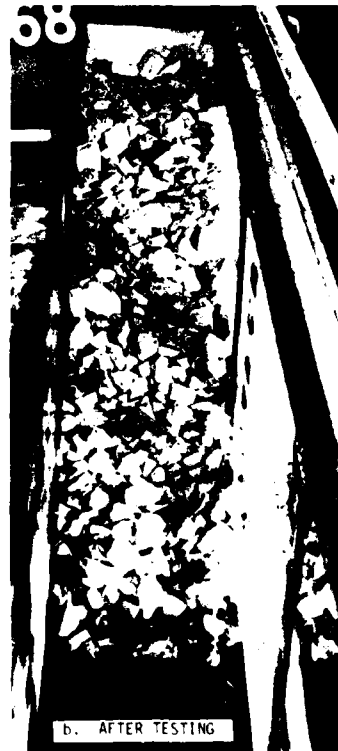
Figure 91. Plan 6A, before and after testing 2.0-sec, 0.75-ft non-breaking wave combined with 1.5-ft static differential head

50. The riprap thickness was increased to 1 ft in Plans 3A, 5B, and 6A (Figures 89a, 90a, and 91a, respectively), to see if this would add some reserve stability to the riprap and reduce the amount of wave energy reaching the filters and sand. These plans were exposed to 2.0-sec, 0.75-ft nonbreaking waves combined with the 1.5-ft static differential head. Only a minor amount of riprap displacement occurred in Plan 3A while a moderate amount of displacement occurred in Plans 5B and 6A. The amount of damage accrued by Plan 3A was significantly less than what had occurred in Plan 3 when exposed to the identical test conditions. The damage in Plans 5B and 6A was similar to what had occurred in Plans 5A and 6 when exposed to the 2.0- and 4.0-sec, 0.70-ft waves combined with the 1.5-ft static differential head. The granular filters on Plans 3A showed no instability or leaching into the riprap. With the increase from 0.5- to 1.0-ft thickness of riprap, there was an obvious decrease in the amount of wave energy reaching the granular filters. Movement of sand beneath the filter fabrics, as noted during earlier tests with the fabric filters, continued to occur in Plans 5B and 6A. The movement of sand in Plan 5B was significant enough to create a hole in the sand streambank (Figure 90b). As with the riprap displacement that occurred on all three plans, the movement of sand under the filter fabric of Plan 5B had stopped well before the end of the test. The after-test conditions of all three plans are shown in Figures 89b, 90b, and 91b.

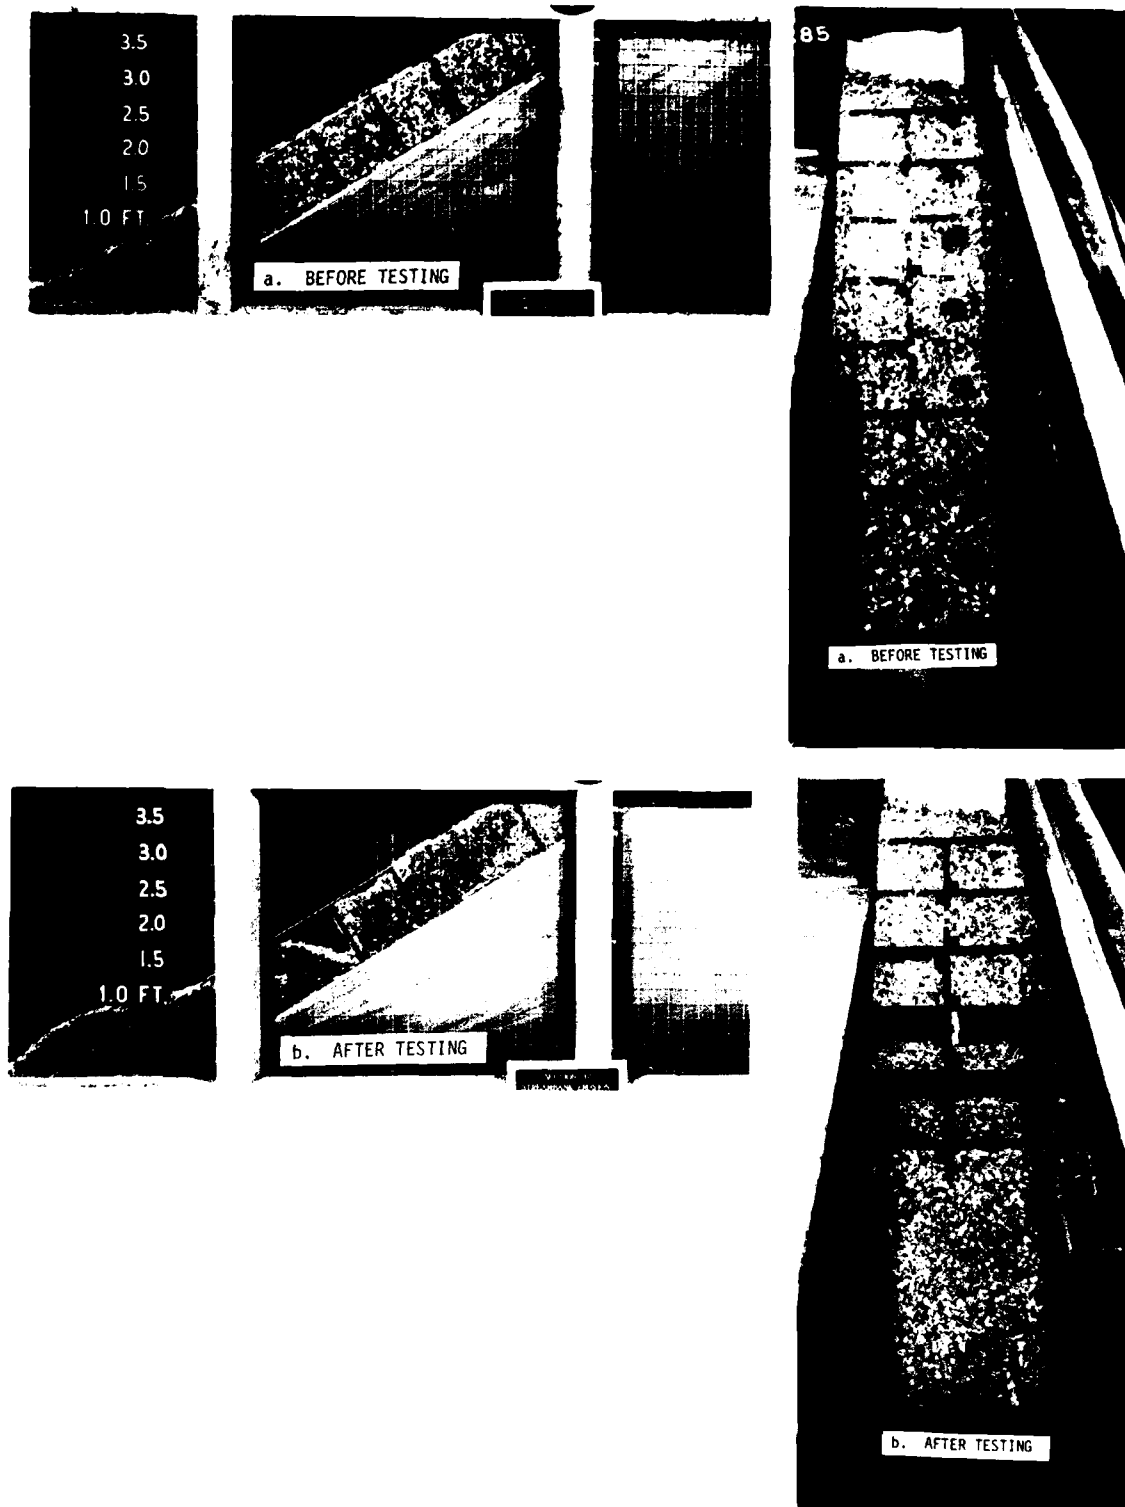
Figure 96. Plan 8C, before and after testing 2.0-sec, 0.75-ft non-breaking wave combined with 1.5-ft static differential head

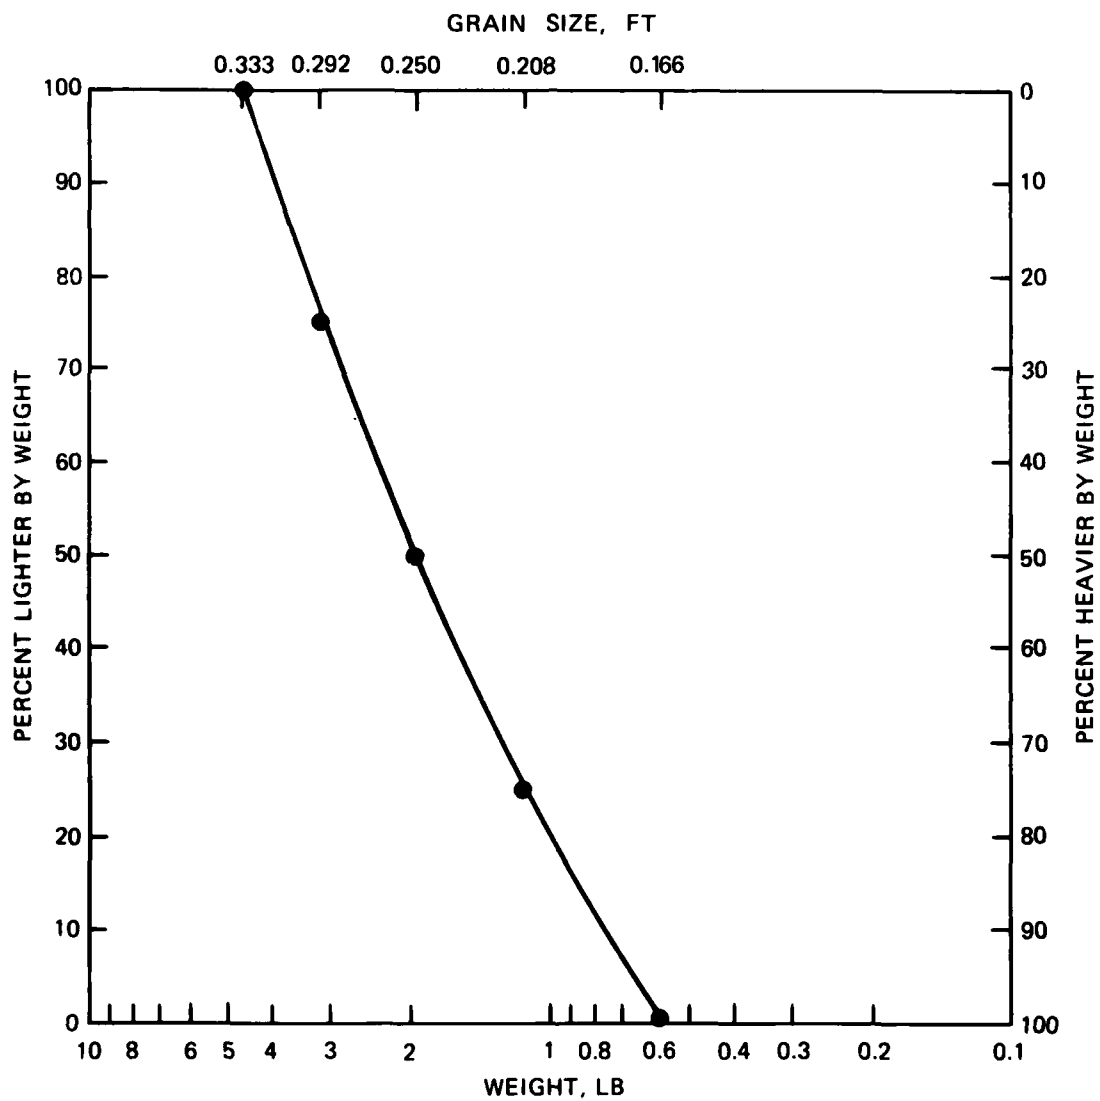
Figure 4. Riprap weight and size gradation, prototype

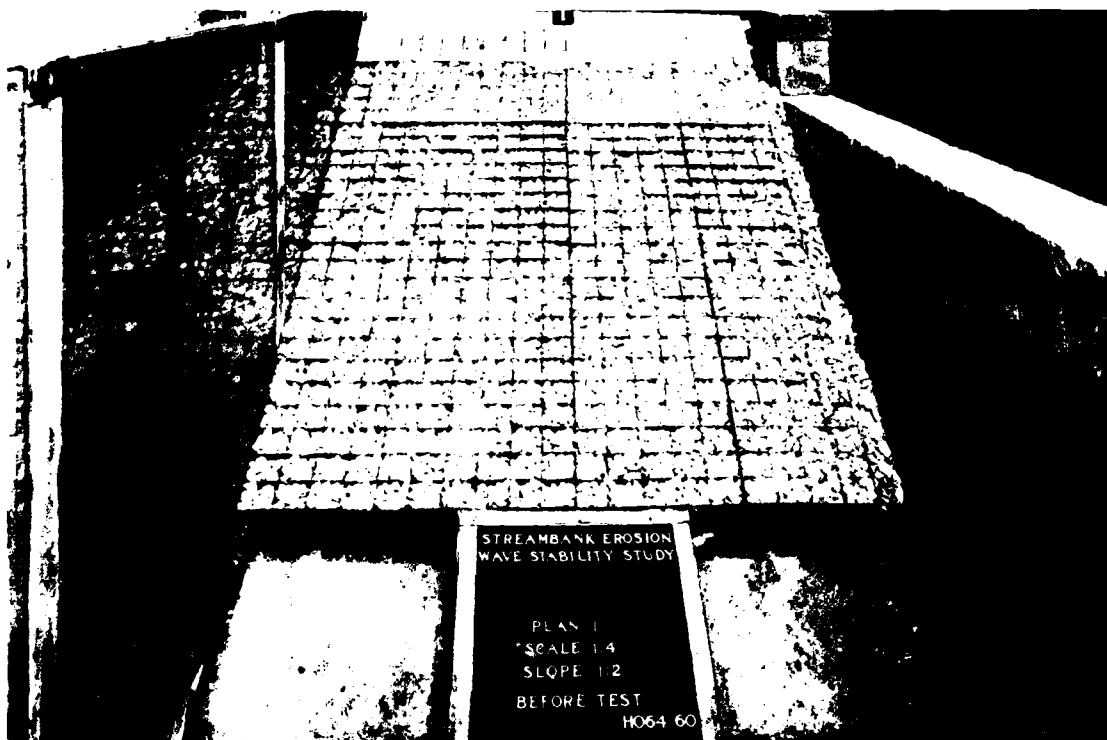
Figure 5. Plan 1, before 90-deg wave attack; wave direction 1

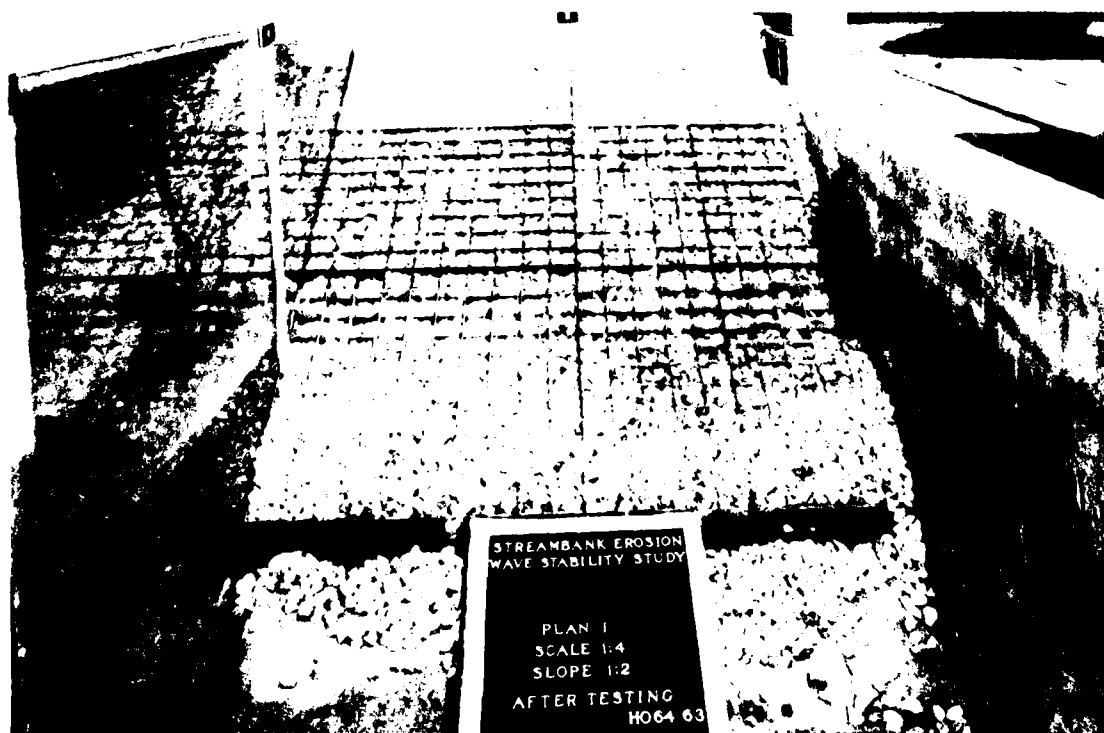
Figure 6. Plan 1, after exposure to 2.0-sec, 1.0- to 1.75-ft nonbreaking waves; wave direction 1

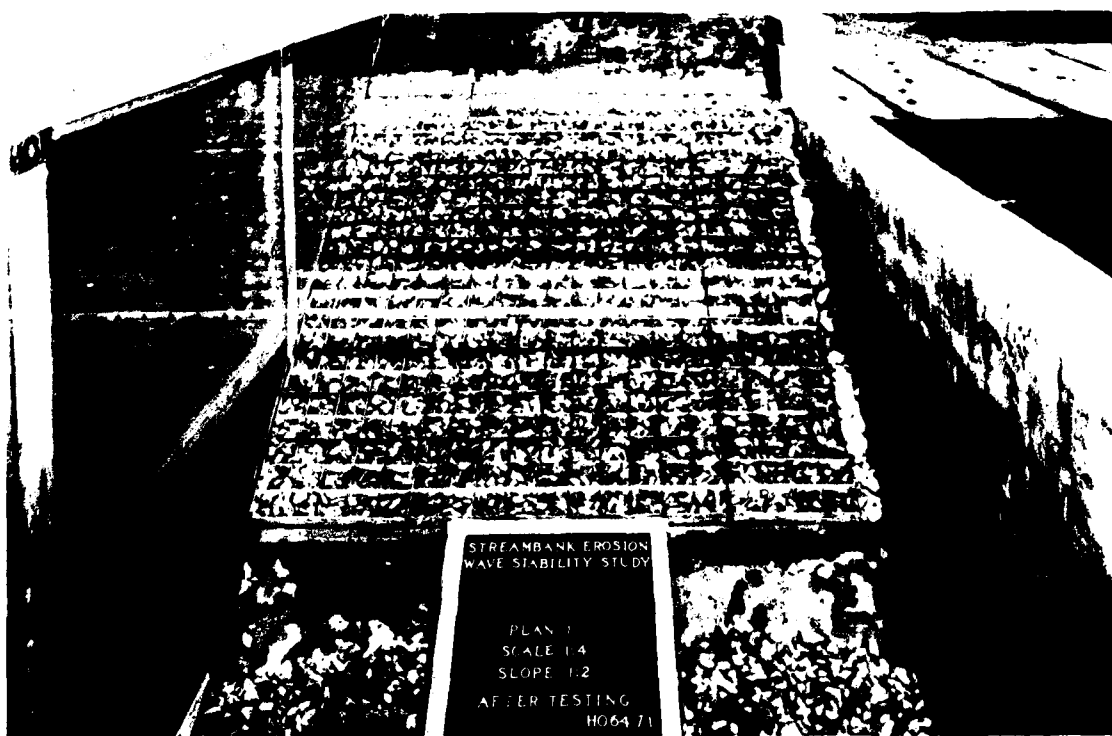
Figure 8. Plan 1, after exposure to 6.0-sec, 1.0- to 2.5-ft nonbreaking waves; wave direction 1

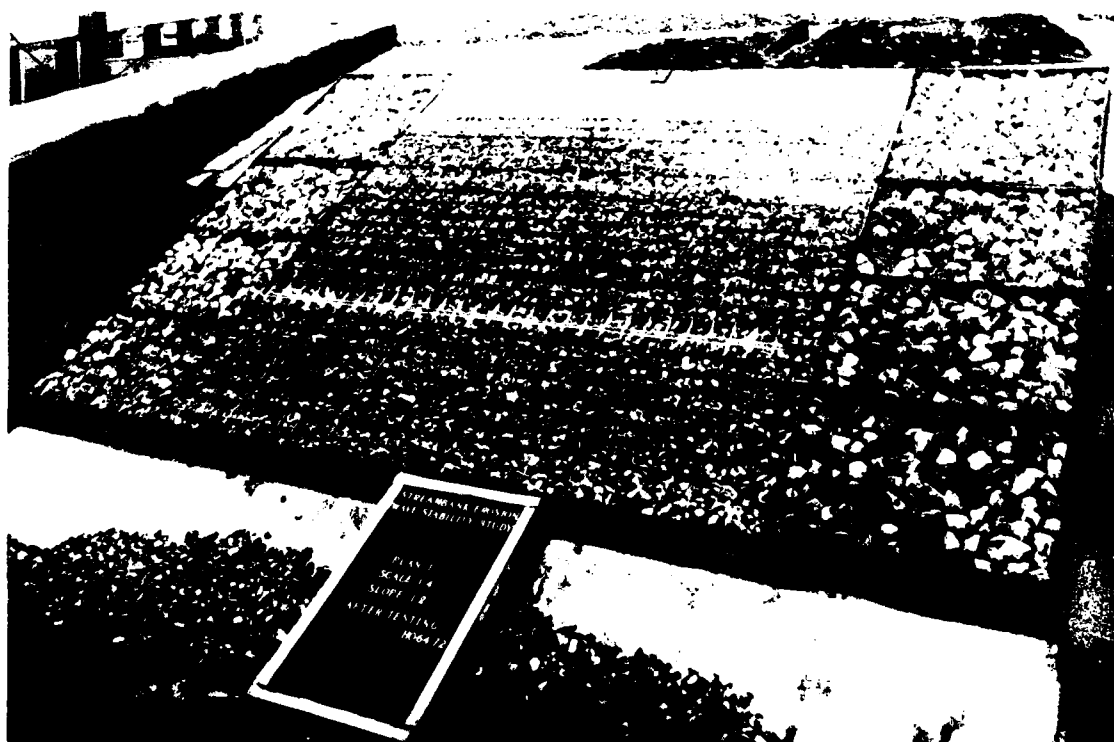
Figure 12. Plan 1, after exposure to 6.0-sec, 1.0- to 2.5-ft nonbreaking waves; wave direction 2

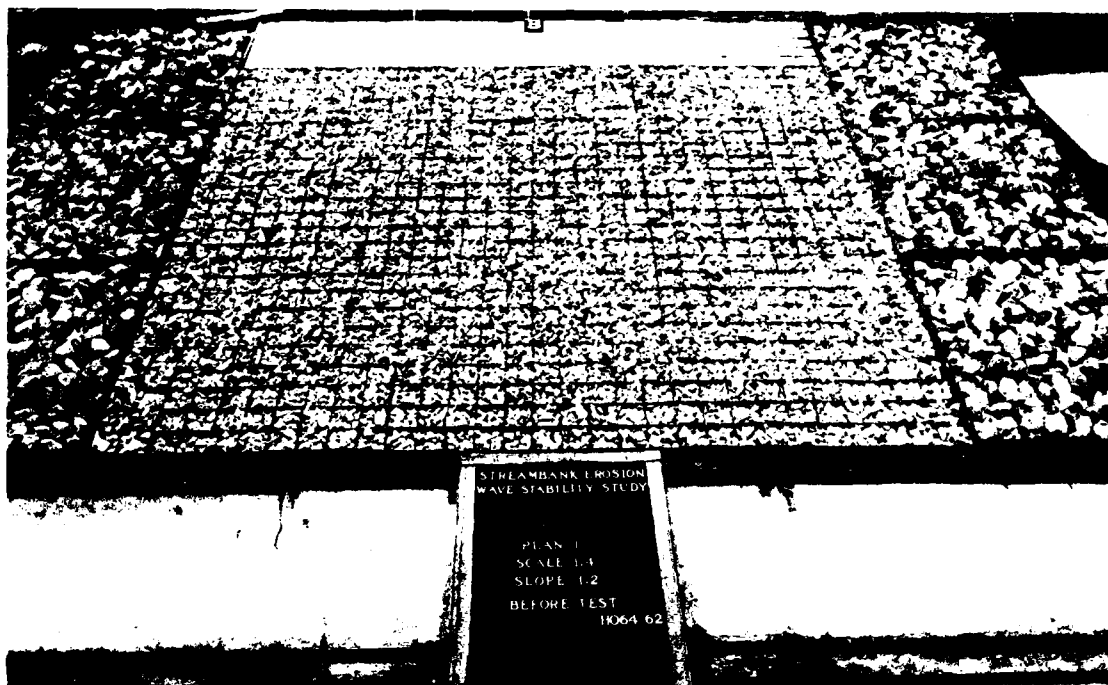
Figure 13. Plan 1, before 30-deg wave attack; wave direction 3

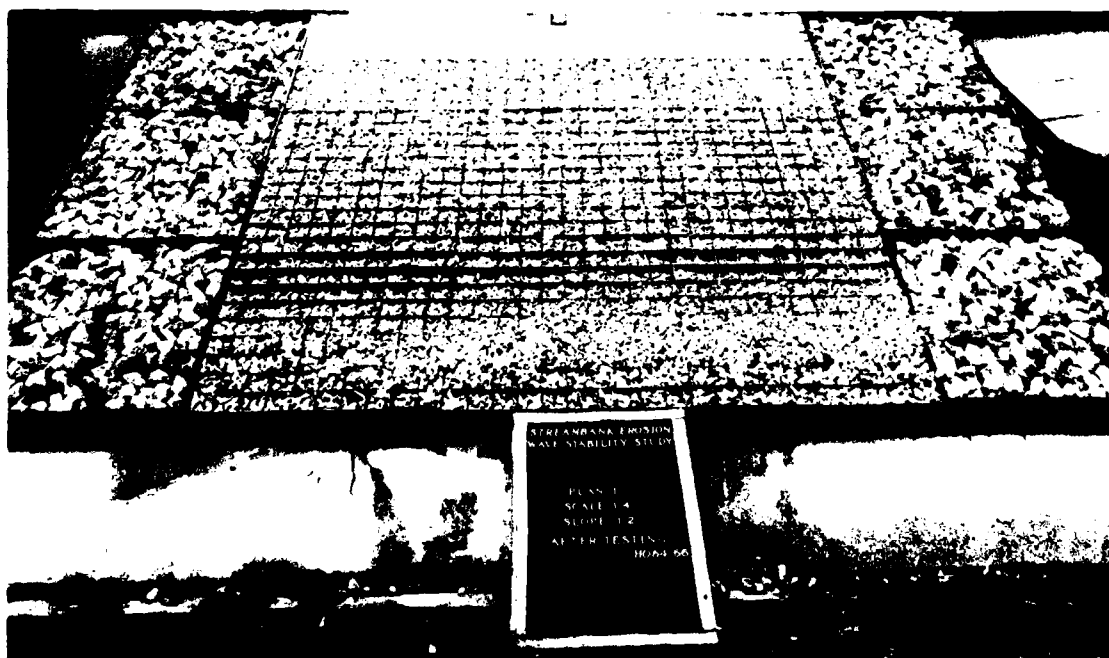
Figure 14. Plan 1, after exposure to 2.0-sec, 1.0- to 1.75-ft nonbreaking waves; wave direction 3

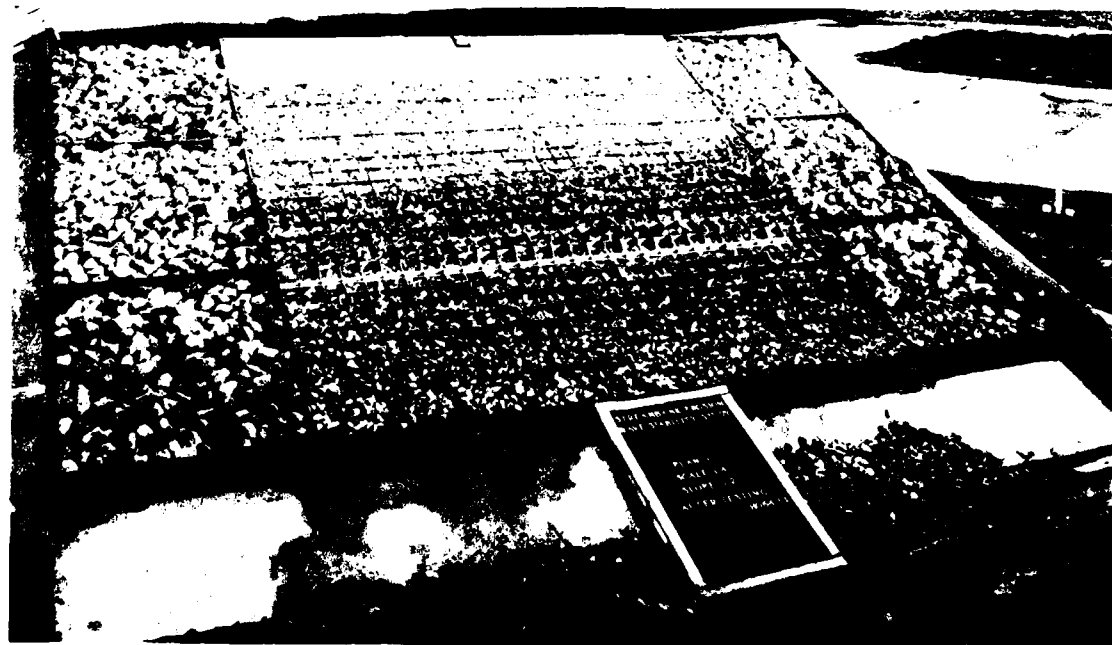
Figure 16. Plan 1, after exposure to 6.0-sec, 1.0- to 2.5-ft nonbreaking waves; wave direction 3

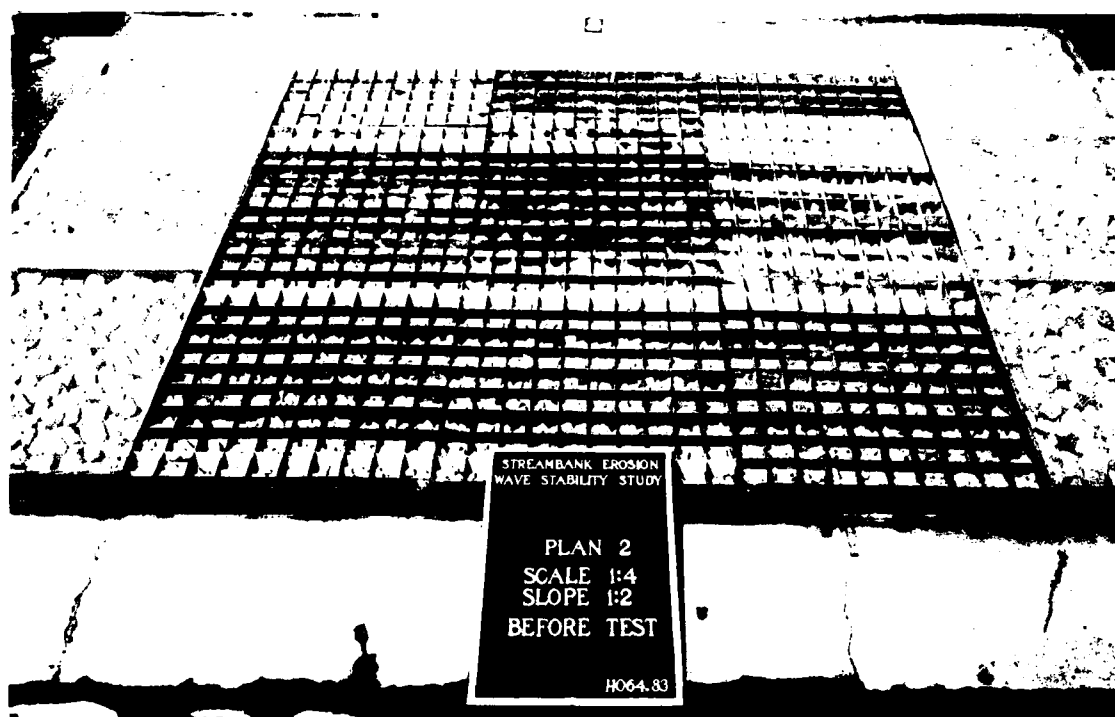
Figure 21. Plan 2, before wave attack from wave direction 3

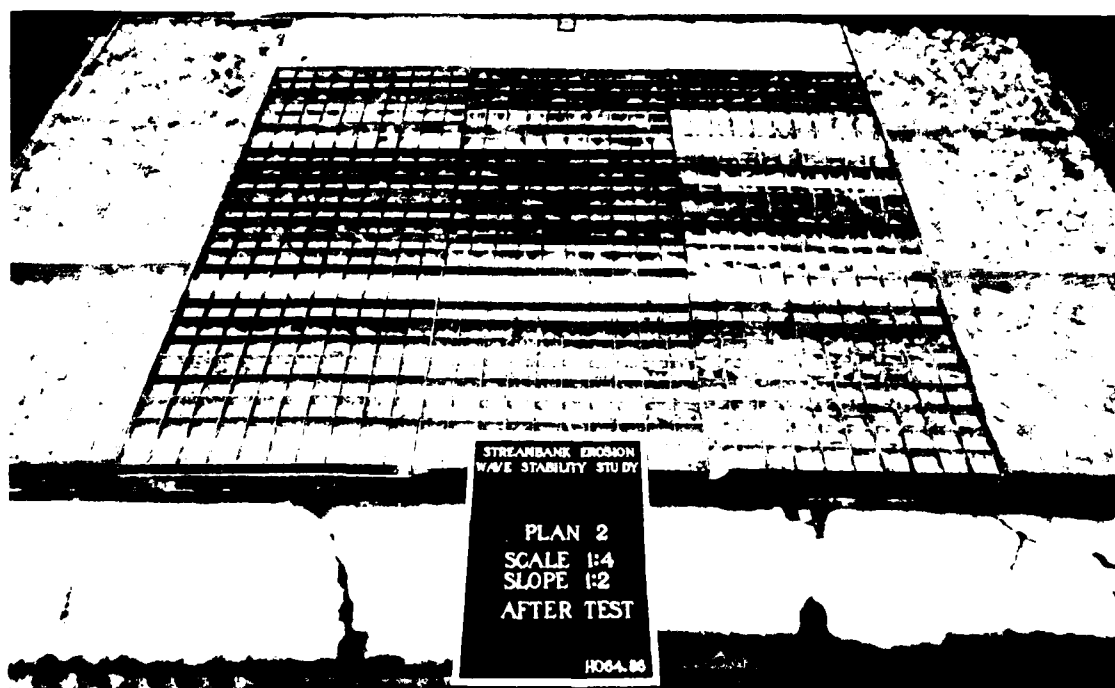
Figure 22. Plan 2, after exposure to 2.0-sec, 1.75-ft, 4.0-sec, 3.0-ft, and 6.0-sec, 2.5-ft nonbreaking waves; wave direction 3

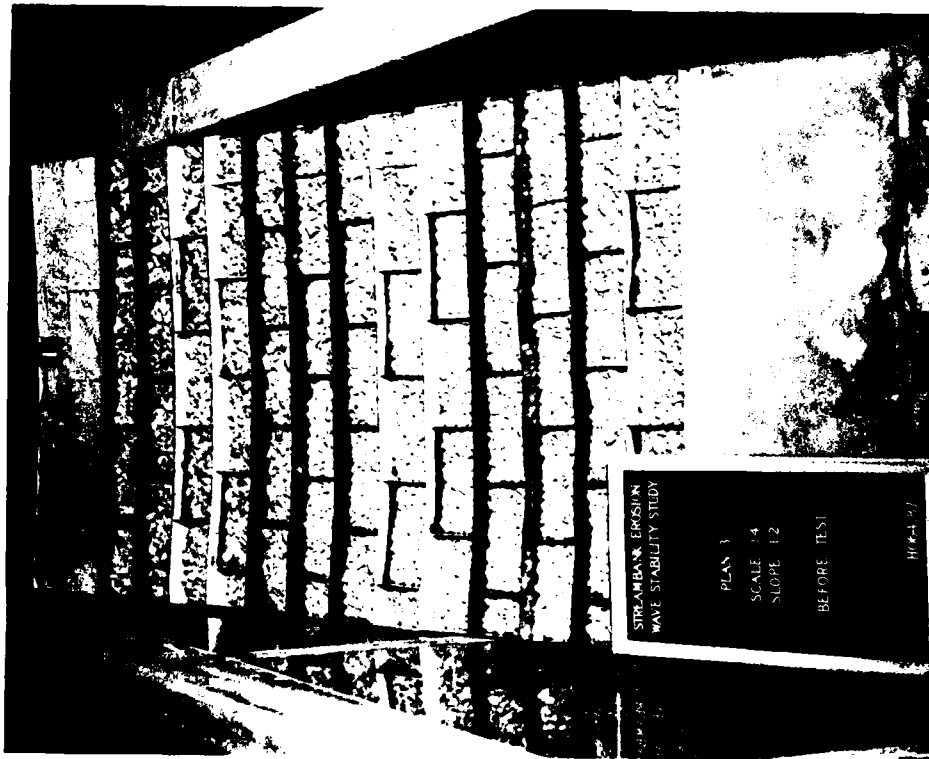
Figure 23. Plan 3, before wave attack from wave direction 1

11. Plan 3 (Figures 23, 25, and 28) was exposed to 2.0-sec, 1.0- to 2.0-ft, and 6.0-sec, 1.0- to 3.0-ft nonbreaking waves. Photographs were taken and the structures were rebuilt after testing the range of wave heights at each wave period. For the two wave periods and three angles of wave attack, Plan 3 was stable for wave heights up to and including 1.5 ft. Some reorientation of the riprap occurred in the individual cells but no bank exposure occurred. Wave heights above 1.5 ft caused spot exposure of the streambank. No riprap was displaced out of the cells, but it shifted downslope and forward in the cells causing
